PROSTHETIC VALVE NON-STRUCTURAL DYSFUNCTION - PANNUS EXCISION WITH OR WITHOUT VALVE REPLACEMENT - A CASE SERIES

Keywords:
Prosthetic valve dysfunction, Pannus,
Pannus excision, Redo sternotomy.

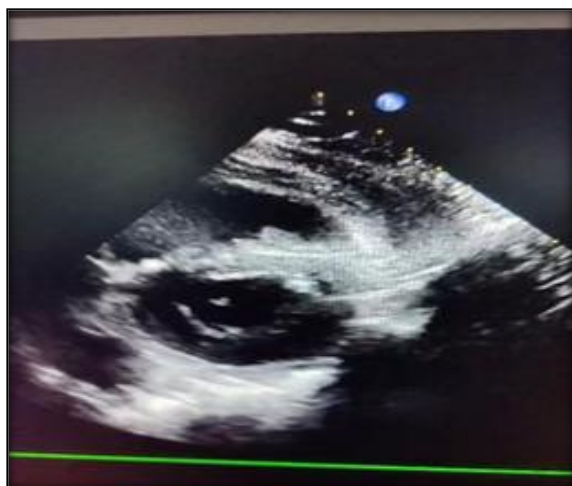
Preoperative echocardiography suggested a stuck prosthetic mitral valve, possibly due to prosthetic valve thrombosis, with a 15-mmHg gradient. The patient underwent redo sternotomy with thrombus excision. Postoperative echocardiography revealed a normally functioning prosthetic mitral valve with a 5-mmHg gradient [Figure 5]. The patient recovered uneventfully and was discharged on postoperative day 12.

Figure 5: Post-op echo PLAX view

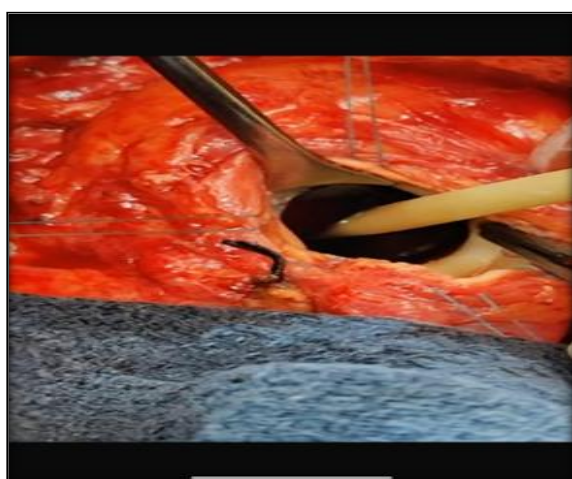
Figure 6: Valve opening after pannus excision
